# Assessment of Management Techniques to Reduce Woodpecker Damage to Homes

**ABSTRACT** Woodpecker damage to homes and buildings is a widespread and locally severe problem in vertebrate pest control. Woodpeckers may cause an average of \$300 (United States currency) in damage to affected houses, resulting in millions of dollars of property damage annually in the United States. However, there is no known, practical, consistently effective technique to prevent woodpecker damage. We tested the effectiveness of 6 woodpecker control techniques available commercially, used anecdotally by homeowners, and recommended by wildlife specialists in different Cooperative Extension publications. These deterrents included Prowler Owls, Irri-Tape™, the Bird Pro Sound System, Scare-Eyes (all manufactured by Bird-X, Inc., Chicago, IL), suet feeders, and roost boxes. We conducted our study in late spring and autumn during August 2003 through December 2004 in the Town of Ithaca, Tompkins County, New York, USA. We evaluated 16 homes with active woodpecker damage, and visited each house about 3 times per week to determine a rate of new woodpecker holes per day. We then placed a deterrent at the house an

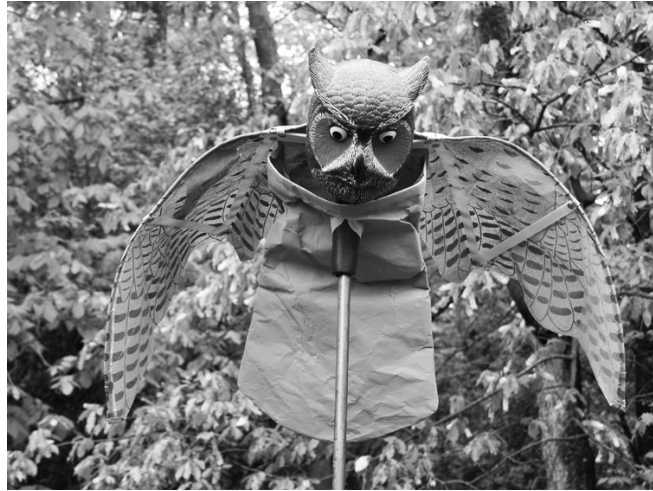
**Figure 1.** Prowler Owl mounted on a post and tested as a woodpecker deterrent, Ithaca, New York, USA, August 2003 to December 2004.

sized plastic owls with extendable heavy paper wings. Irri-Tape (Fig. 2) resembles silver reflective streamers. We suspended it from the eaves and siding of a house, often on a string, and allowed the tape to hang freely. Roost-box dimensions were adapted from Shackelford (2000). Scare-Eyes were bright orange and yellow plastic holographic eyes strung on fishing line. The Bird-Pro Sound System played the call of a downy woodpecker in distress, followed by the call of a sharp-shinned hawk (*Accipiter striatus*). We hung suet feeders on metal hooks 1.5 m above ground along the face of the house with woodpecker damage. Feeders were 18 × 20 cm, constructed of wire mesh, and were accessible from all sides. At the onset of the study, we filled the feeders with peanut butter-flavored suet. However, gray squirrels (*Sciurus carolinensis*) were attracted to the peanut butter suet, and would empty the feeders before our next visit 2 days later. To address this problem, we switched to all-beef suet, which greatly decreased, but did not eliminate, the squirrel activity at the suet feeders.

We hung suet feeders from iron shepherd hooks at a 2-m height in the yard near the damaged side(s) of the home. If one home face was damaged, we used one feeder; if 2 faces were damaged, we used one feeder on each face. Scare-Eyes were hung from the eaves or siding at the 4 corners of the home, and allowed to sway in the breeze. We placed Prowler Owls on 3-m poles in the yard near the side of home with damage.

**Prowler Owls.**—We tested Prowler Owls at 6 houses; all were earth colored. Two were sided with cedar clapboards (1 painted, 1 stained), 1 with shakes (stained), 1 with tongue-and-groove boards (painted), and 2 with grooved plywood (1 painted, 1 stained). The average trial duration for each house, including pretreatment, treatment,

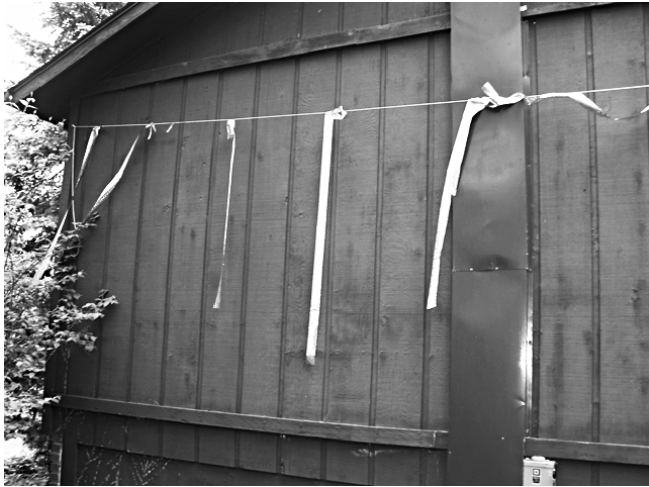
**Figure 2.** Irri-Tape<sup>TM</sup> suspended from a string as a deterrent to woodpeckers damaging siding, Ithaca, New York, USA, August 2003 to December 2004.

**Irri-Tape.**—We evaluated Irri-Tape 10 times at 7 different houses (3 homes were tested in 2 damage seasons); all were earth colored. Two of the 7 homes were sided with clapboards (both stained), 2 with shakes (1 stained, 1 painted), 2 with grooved plywood (1 stained, 1 painted), and 1 with tongue-and-groove boards (stained). On average we observed homes for 46 days, with an average treatment period of 31 days. We documented roost holes and drumming damage at 5 of 7 houses, and foraging damage occurred at all 7 homes.

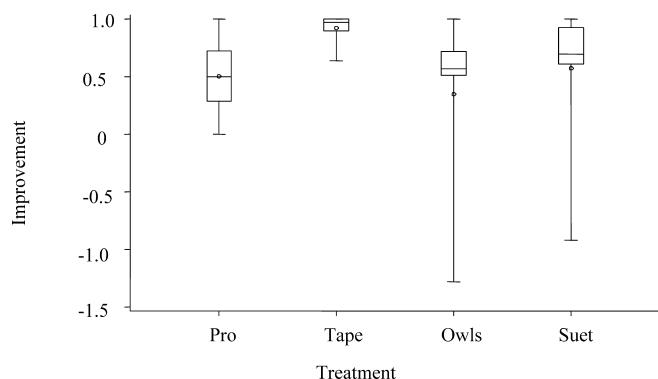
**Figure 3.** Boxplot showing medians, interquartile ranges, and upper and lower limits for the level of improvement for each treatment, Owls (Prowler Owls; Bird-X, Inc., Chicago, IL), Pro (Bird Pro; Bird-X, Inc.), Suet (suet feeders), and Tape (Irri-Tape; Bird-X, Inc.), Ithaca, New York, USA, August 2003 to December 2004.

We first examined boxplots of the improvement score for each of the 4 treatments (Fig. 3). For these boxplots, the value 1.0 indicated woodpecker damage ceased, and 0 indicated no change in damage rates after deterrent installation. We examined the Wilcoxon rank-sum values for the improvement scores to assess differences between the treatment means (Steel and Torrie 1980). We then performed a Wilcoxon signed-rank test in Minitab (Version 13.1; State College, PA). We used a one-tailed test for absolute improvement on each treatment separately, and our null hypothesis was that improvement was  $>0.5$ . We performed one-tailed tests because we did not expect damage rates to increase after installation of a deterrent.

All of the devices appeared to reduce woodpecker damage at some homes. Irri-Tape showed the highest improvement score, with the lower quartile range either nearly equal or higher than the highest upper quartile ranges for Prowler Owls, Bird Pro, and suet feeders, which all showed similar improvement rates. The lower limits of both suet feeders and Prowler Owls were well below zero, meaning that some

houses exhibited an increase in damage rates after installation of a deterrent. Bird Pro exhibited the lowest median value for improvement. All deterrents had upper limits of 1.0, meaning that after the installation of a treatment device, woodpecker damage ceased for  $\geq 1$  home.

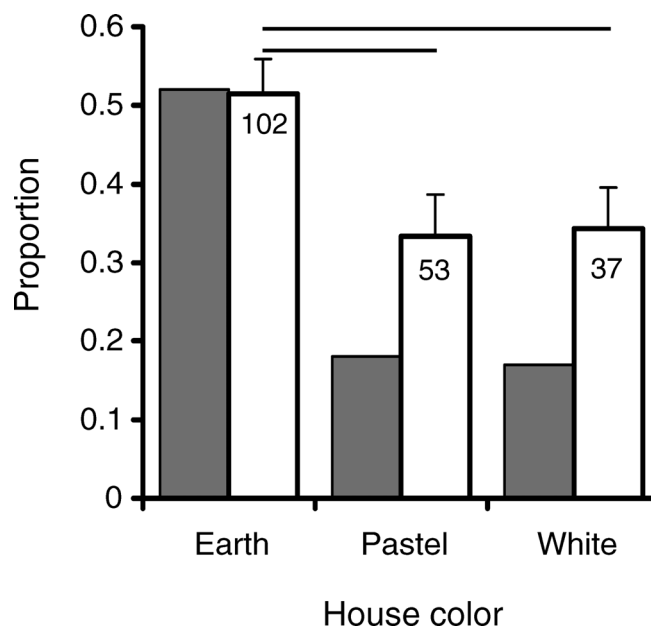
**Figure 4.** Proportion of painted homes with reported woodpecker damage in relation to house color, Ithaca, New York, USA, August 2003 to December 2004. Gray bars show the uncorrected proportion of homes with woodpecker damage, white bars represent least-squares mean proportion and standard error after correcting for house siding and yard types. Numbers above bars represent total number of houses ( $n$ ) examined.

In a broader community survey of woodpecker activity near Ithaca, of the 1,185 homes visited, 394 houses (33.2%) had some form of woodpecker damage, either property damage or nuisance activity (noise). To examine the relationship between house color and property damage, we selected only homes with paint sealant (no houses with white or pastel stain existed) and ran a logistic regression analysis including siding, yard type, and interaction terms. House color affected damage probability ( $\chi^2 = 36.5$ ,  $P < 0.001$ ; Fig. 4). Using least-squares means to make pair-wise comparisons, earth-colored houses ( $n = 102$ ) had more woodpecker damage than white ( $n = 37$ ,  $\chi^2 = 17.8$ ,  $P < 0.001$ ) or pastel-colored homes ( $n = 53$ ,  $\chi^2 = 28.5$ ,  $P < 0.001$ ). Pastel and white houses did not differ ( $\chi^2 = 0.72$ ,  $P = 0.40$ ).

Homes sealed with earth-tone paints experienced significantly more woodpecker damage than those painted with bright pastel or white colors, after we adjusted for siding and yard type (Fig. 4). In our study areas, all homes that we observed with stain sealant were earth colored. Twelve of the 16 houses (75%) with active woodpecker damage evaluated during our deterrent trials were covered with earth-colored stains, and the remainder had earth-toned paints. It is clear from our observations of nearly 400 homes
