# External characteristics of houses prone to woodpecker damage

**Abstract:** Woodpecker (*Picidae* spp.) damage to houses and buildings is a widespread and locally severe problem, yet the probability and type of damage has never been quantified and related to home characteristics. Woodpeckers excavate holes in homes for a several reasons, mainly for building nest and roost cavities, drumming, and foraging for insects. We examined the external characteristics of houses that were contributing factors in attracting woodpeckers to bore holes in house siding and trim. From March 2001 through April 2002, we surveyed 1,185 houses in the town of Ithaca, Tompkins County, New York. Of the houses visited, 33% had woodpecker problems consisting of either property damage or noise disturbance. The probability of woodpecker-inflicted damage on a house was strongly dependent on siding type. Grooved plywood siding was more likely to be damaged than tongue-and-groove, board-and-batten, clapboard, and nonwood siding types. Probability of damage also increased as the tree density in the yard increased. Interactions occurred between sealant and yard type, and stained houses suffered greater probabili

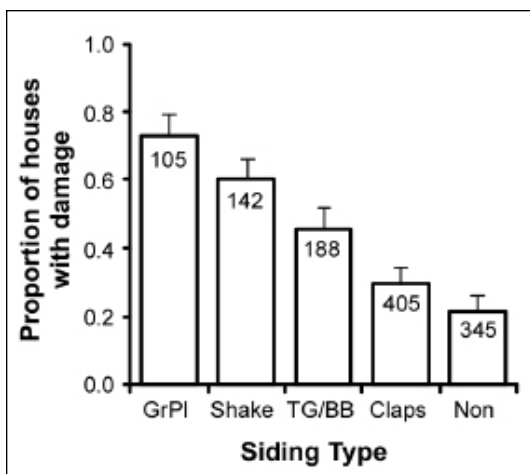
**Figure 2.** Proportion of houses near Ithaca, New York, April 2001 to March 2002, with woodpecker damage for each siding type (least-squares mean proportion and standard error after correcting for other house variables). GrPI = grooved plywood. TG/BB = tongue-and-groove and board-and-batten (pooled categories). Shake = natural and resawn shakes (pooled categories). Claps = natural and hardwood clapboards (pooled categories). Non = nonwood.

The initial logistic regression model for the analysis of damaged versus undamaged houses included siding, sealant, yard type, and all interaction terms. House color was not included in this model because it was auto-correlated with sealant. All 3 variables showed highly significant differences in their effects on woodpecker damage (Table 2). Siding types varied greatly in their susceptibility to damage, ranging from 21 to 73%, and most pairwise comparisons were significant (Figure 2). The density of trees in the yard also had a strong

effect on the probability of damage. Houses in heavily wooded areas were the most prone to woodpecker damage, and the probability of damage decreased in a linear fashion as tree density decreased. The type of sealant on the house affected the likelihood of woodpecker damage, as well. The probability of damage was highest for stained wood (72%), intermediate for painted wood (29%), and lowest for nonwood siding (10%).

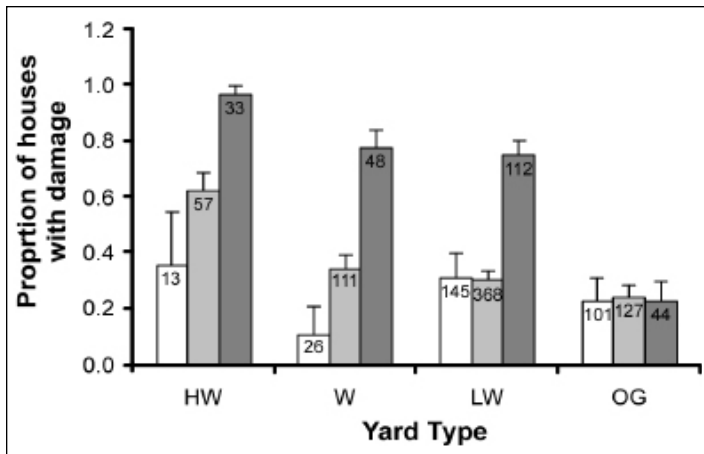
**Figure 3.** Proportion of houses near Ithaca, New York, April 2001 to March 2002, with woodpecker damage for each siding and yard type after correcting for interactions and other effects. Bar color indicates sealant type: white = nonwood, light gray = paint, dark gray = stain. Yard types: HW = heavily wooded, W = wooded, LW = lightly wooded, OG = open grassy.

The final logistic regression model also included a significant interaction between sealant and yard type (Table 2). Stained houses suffered greater probabilities of damage in all wooded yards, but not in open grassy yards (Figure 3). Painted houses exhibited lower levels of damage, with damage probability increasing only in heavily-wooded yards. Damage rates on nonwood houses were unaffected by yard characteristics. There was also an association between yard and sealant type, with stained houses having a tendency to be situated in heavily-wooded areas ( $\chi^2_6 = 52.6$ ,  $P < 0.001$ ). Among the houses with heavily-wooded yards, 32% had stained wood siding, and this percentage decreased to 26%, 18%, and 16%, respectively, in the less-wooded yard categories. Vinyl sidings were more common in lightly-wooded and open, grassy yards.
